Manhole Inspection Summary

Manhole # S35Q__062MH

Location Address: **1101 s hanover st**

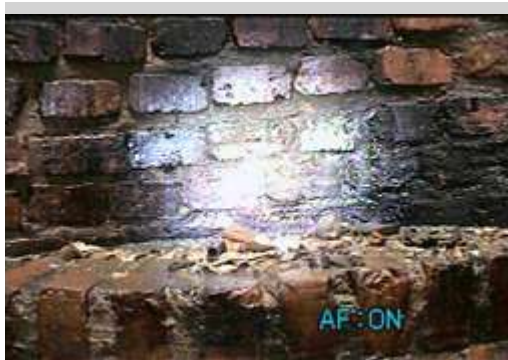
Miscellaneous

bench debris

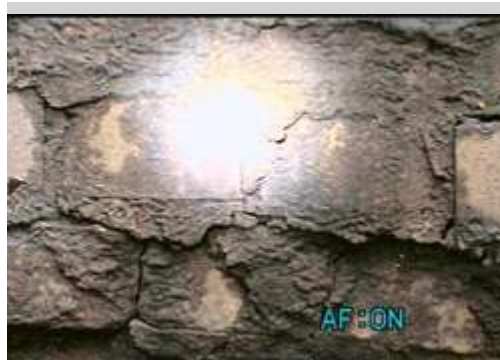
Defect 5

Condition: ☐ Sound ☒ **Cracked** ☐ Root Intrusion ☒ **Loose Brick** ☐ Deteriorated

Infiltration: ☐ None ☒ **Joint** ☐ Cracks ☐ Mortar ☐ Roots ☐ Wall

chimney cracked with loose brick

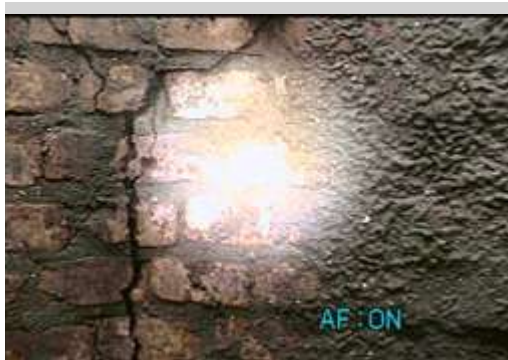
Defect 4

Condition: ☐ Sound ☒ **Cracked** ☐ Root Intrusion ☐ Loose Brick ☐ Deteriorated

cracked corbal; signs of infiltration from chimney joint

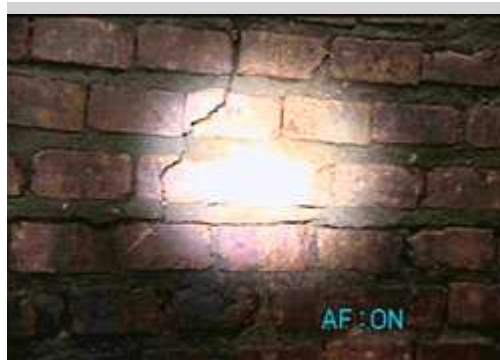
Defect 3

Comments **bad crack from top to bottom**

Condition: ☐ Sound ☒ **Cracked** ☐ Root Intrusion ☐ Loose Brick ☐ Deteriorated

cracked barrel

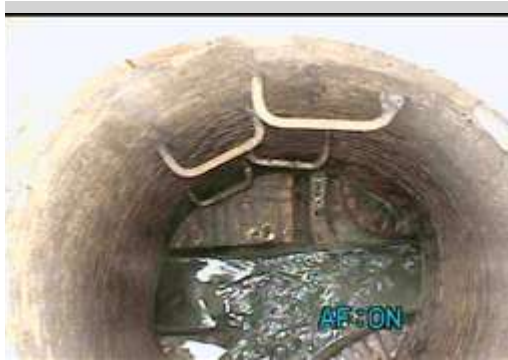
Defect 1

Count: **4** Missing: **0** ☒ **Corroded**

corr steps
